RE: San Miguel Electric Coop, Inc.
San Miguel Mine, Permit No. 11G
Final Action Notification, NOV 118A

**Statement of Inspector's Observations
Notice of Violation No. 118A
Issued to San Miguel Electrical Cooperative, Inc.
San Miguel Mine, Permit No. 11G**

COAL MINE INSPECTION REPORT

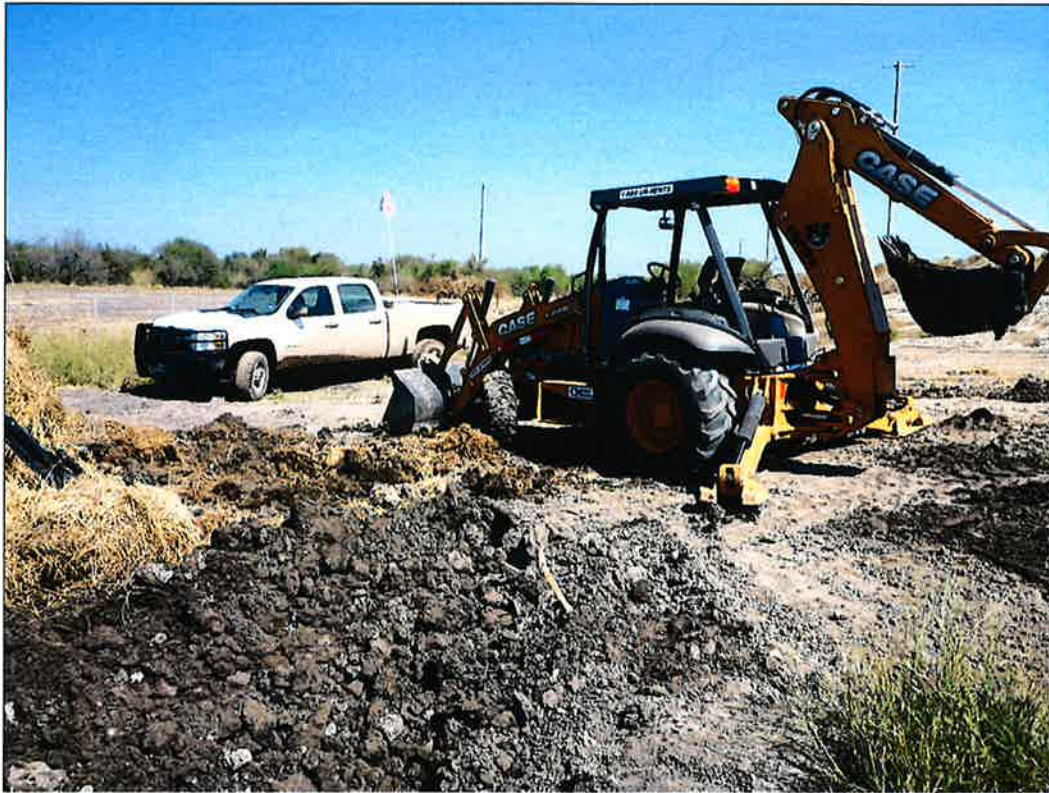
Photo 1. Backhoe staged at the BN-2 Drop Structure in October (view north).

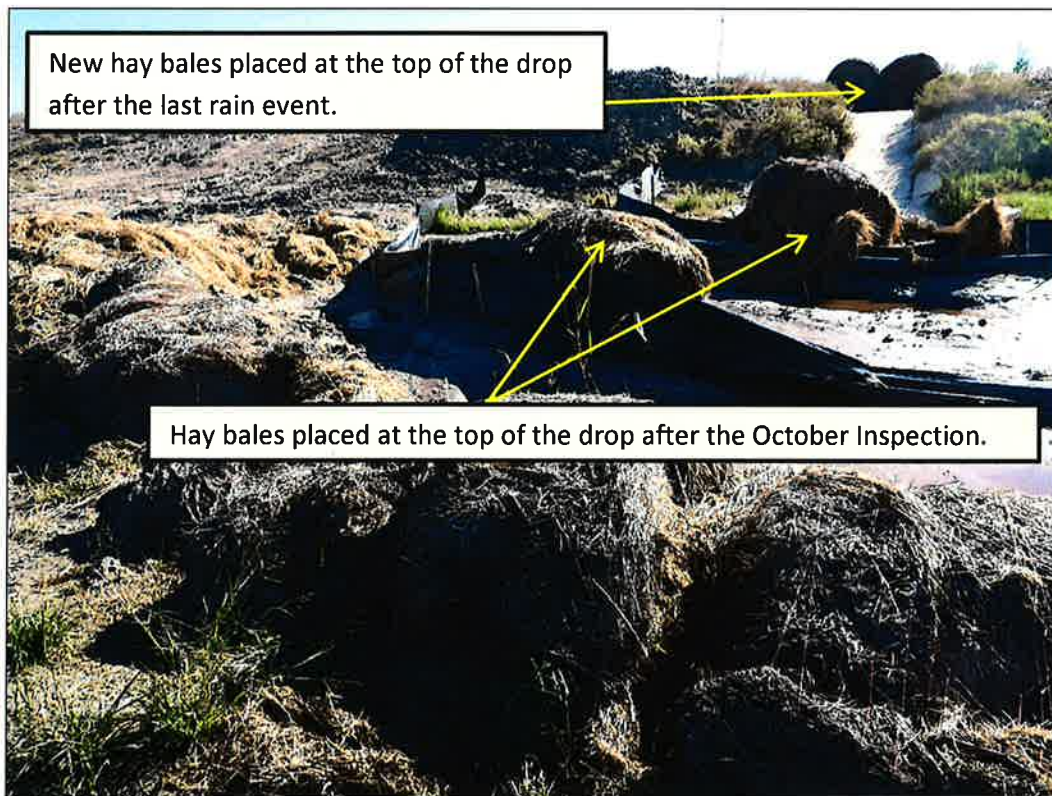
Photo 2. Hay bale failure (view east).

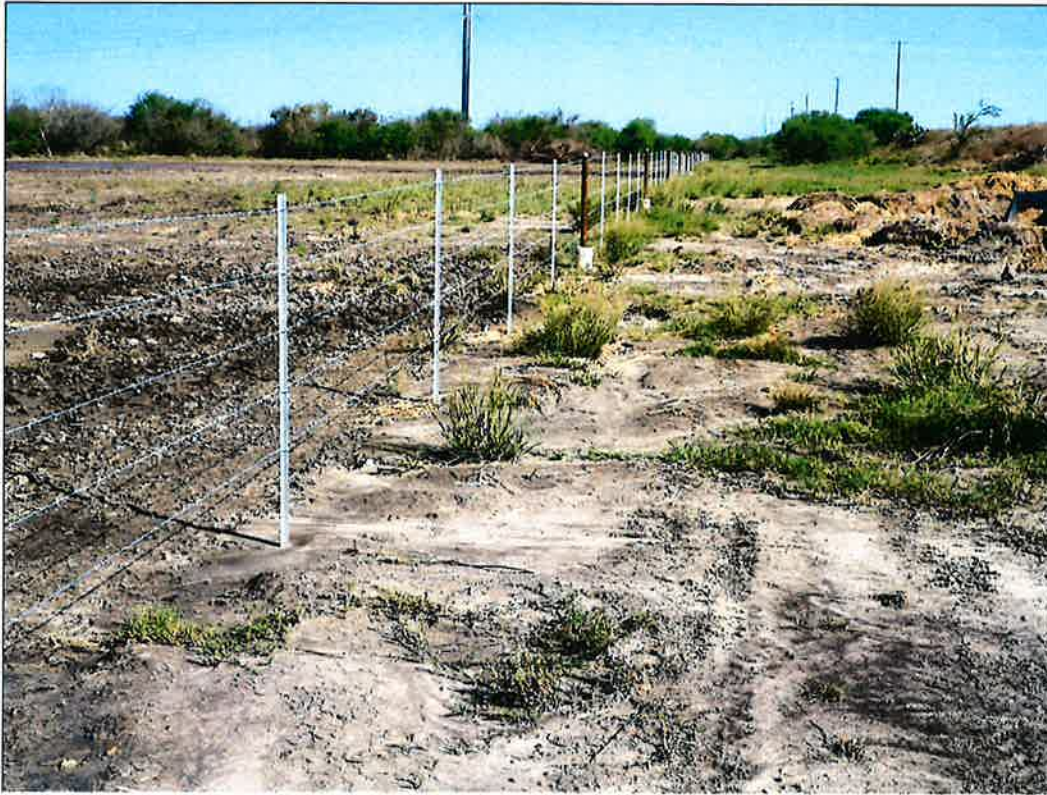
Photo 3. Permit Boundary (fence line) with no sediment control measures (view north).

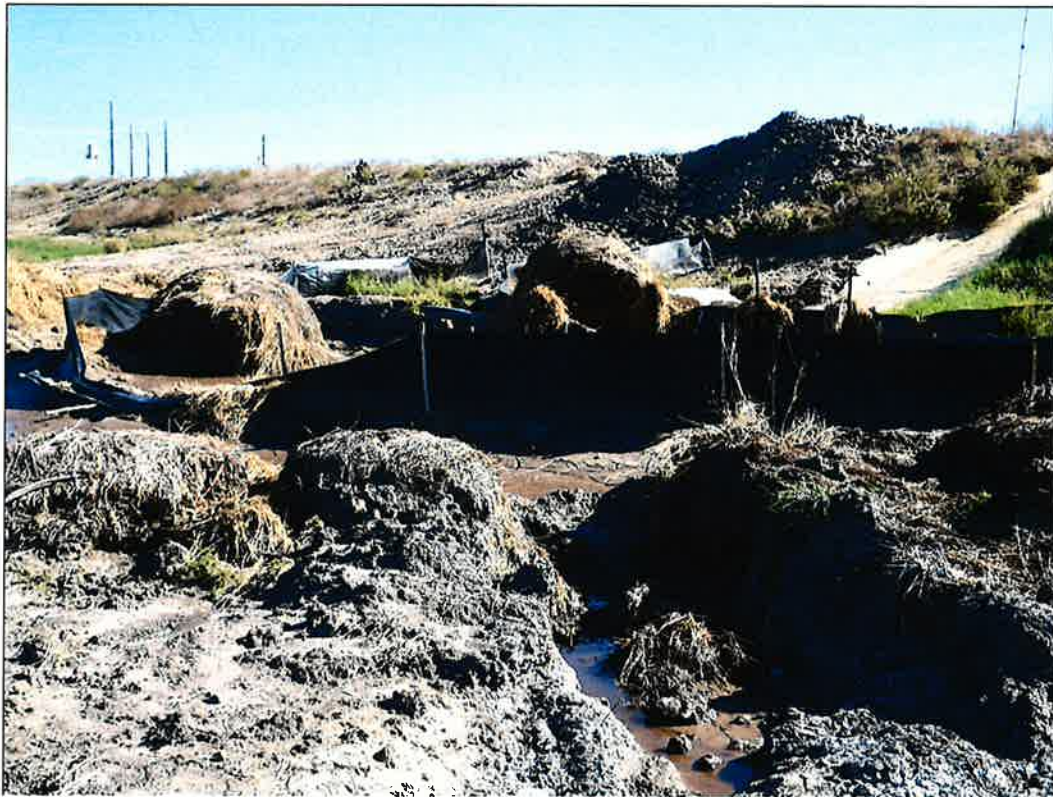
On November 18, 2015, SMRD Inspector Barry Gibbs and I inspected the BN-2 Drop Structure to observe if the sediment control measures implemented by SMECI were functioning properly. The BN-2 Drop Structure has been observed every month since SMRD Inspector, Jacob Eickstead, issued NOV 114A at this location in April 2015, for sediment leaving the permit area. During the following six months, Mr. Eickstead informed SMECI that immediate action is needed to ensure that sediment will not flow out of the permitted area and onto the adjacent property again. During my October inspection, SMECI representative David Burris and I traveled to the site for inspection. A backhoe was brought in (photo 1) on the second day of the inspection and attempted to remove sediment from the sump, but due to saturated soils, SMECI suspended the operation until the area dried out. I recommended to Mr. Burris that additional silt fence be installed around the sump location and along the permit boundary as extra protection. During the inspection on November 18, 2015, it appeared that two round bales of hay were added to the top of the drop structure (photo 2), the previously placed hay bales had washed down into the sump during the earlier rain events. Also, no additional silt fence was observed installed around the sump or along the permit boundary fence (photo 3). The hay bales that were installed earlier in the year around and below the sump, have silted up and have eroded, leaving large gaps between the bales allowing sediment to freely flow through and out of the permitted area (photo 4).

Upon review of the Regulations, Permit No. 11G and discussion with the I&E Manager, Notice of Violation 118A was issued to SMECI for failure to maintain appropriate sediment control measures at the sump below the BN-2 Drop Structure. This is a violation of Texas Coal mining Regulations Title 16, Texas Administrative Code §12.343 and section .154 of Permit No. 11G.

Photo 4. Ineffective sediment control (view northeast).

Remedial Action Required: Install adequate sediment control measures around the drop structure and the permit boundary to prevent sediment from leaving the permit area and plant the area with approved grass species.

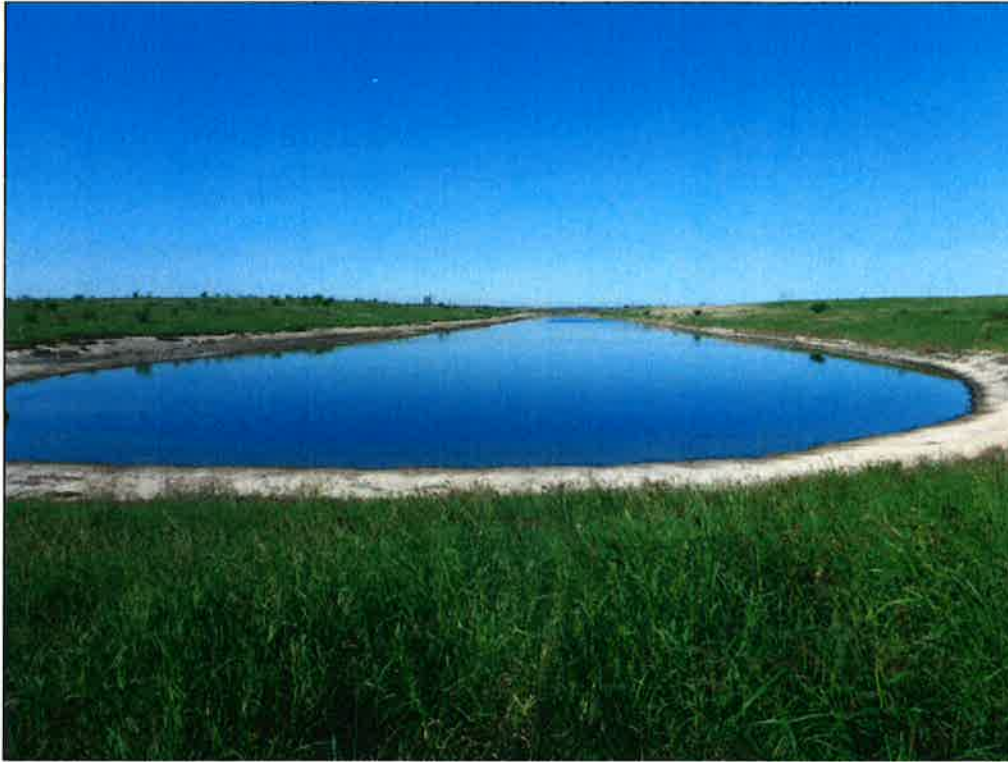
Photo 1. Vibrant vegetation around Pond 11 (view west).

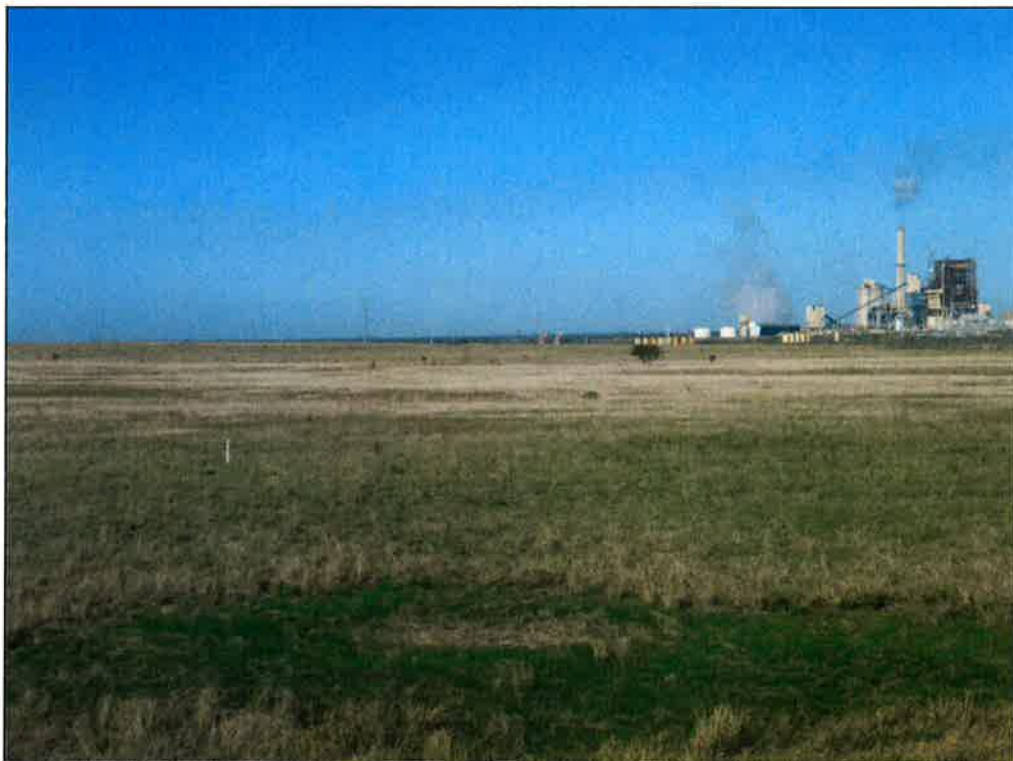
Photo 2. Vegetation west of Pond 1 (view northwest).

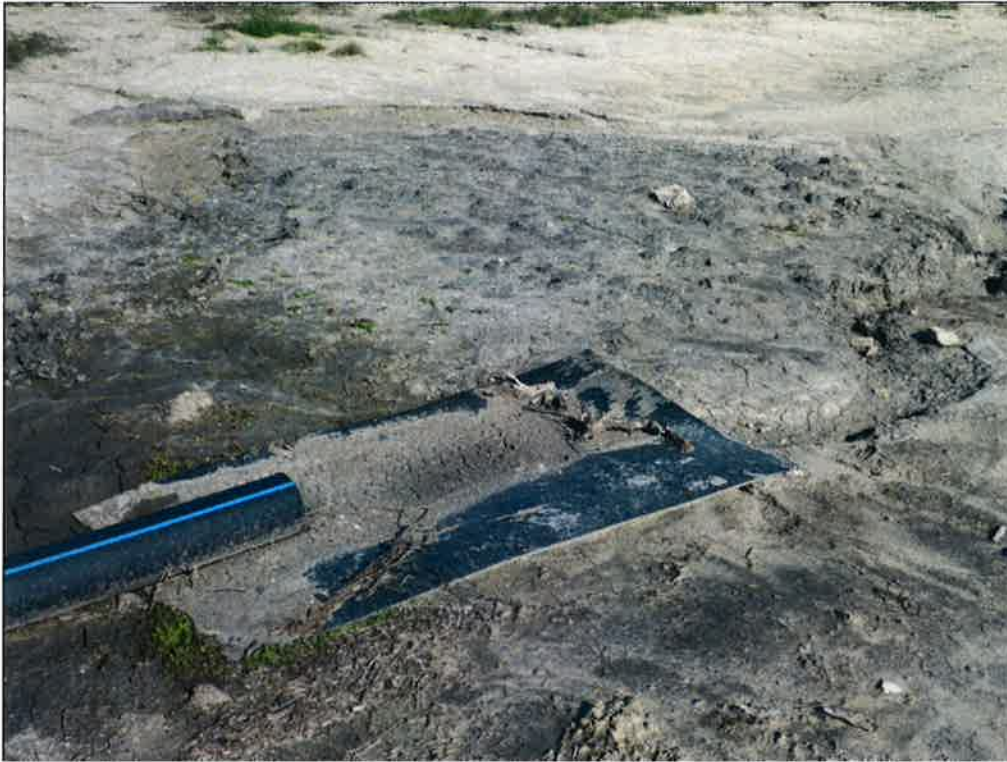
SMECI staff has corrected the minor erosion issue, noted in the September Inspection Report, concerning the discharge pipe located near the southeast corner of Pond 11. The area appeared to have been repaired and piece of conveyor belt was placed underneath the discharge pipe to prevent scouring of the soil when discharging (photo 3).

Photo 3. Conveyor material underneath the polypipe located south of Pond 11 (view northwest).

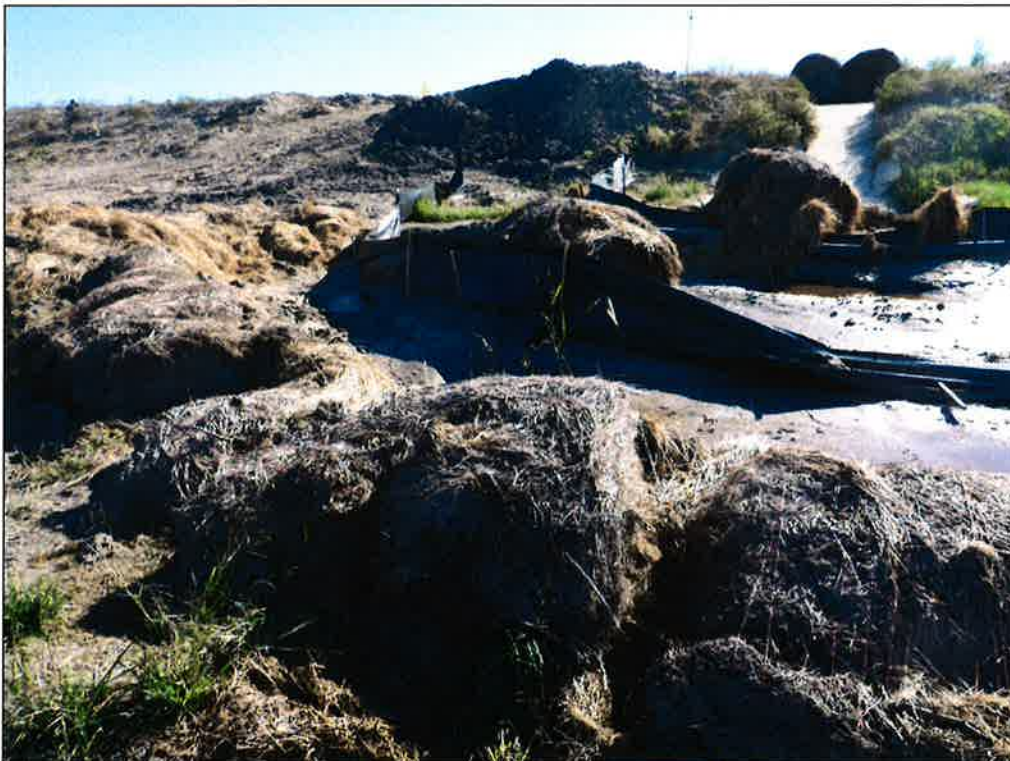
A significant breach in containment was observed at the BN-2 Drop Structure. After months of repeated warnings and recommendations from SMRD Inspector, Jacob Eickstead, the sediment control measures failed allowing sediment and water to flow freely out of the permit boundary and onto the adjacent landowner property (photos 4-7). Additional hay bales were placed at the top of the drop structure after the October inspection, but had since washed down to the bottom of the drop structure. In a phone conversation with SMECI representative, Dave Burris, I informed him that due to the lack of installing sufficient sediment controls and the disregard to SMRD inspector's warnings that a notice of violation would be issued for this area. Base material was brought in and staged at the Pond 10 Access Road entrance (photo 8). According to Mr. Burris, this material will be used to raise the haulroad and divert the runoff to the appropriate sediment ponds (Pond I and Pond J) and away from the BN-2 Drop Structure.

Photo 4. Sediment control failure at the BN-2 Drop Structure (view northeast).

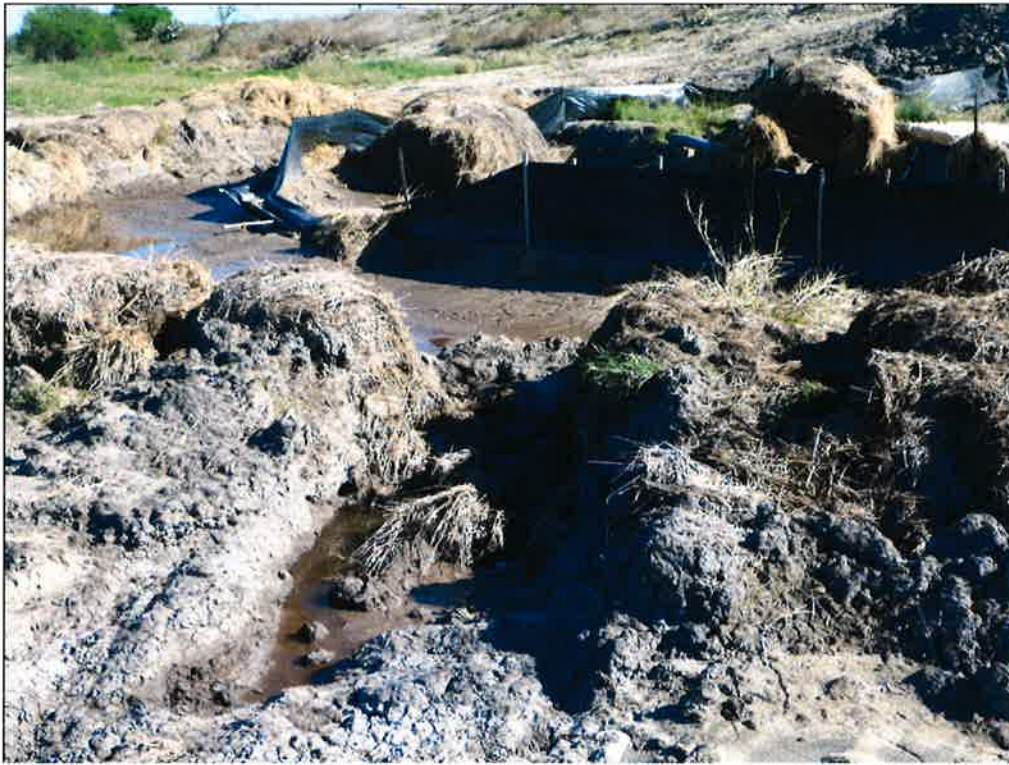
Photo 5. Hay bale and sediment eroded away (view northeast).

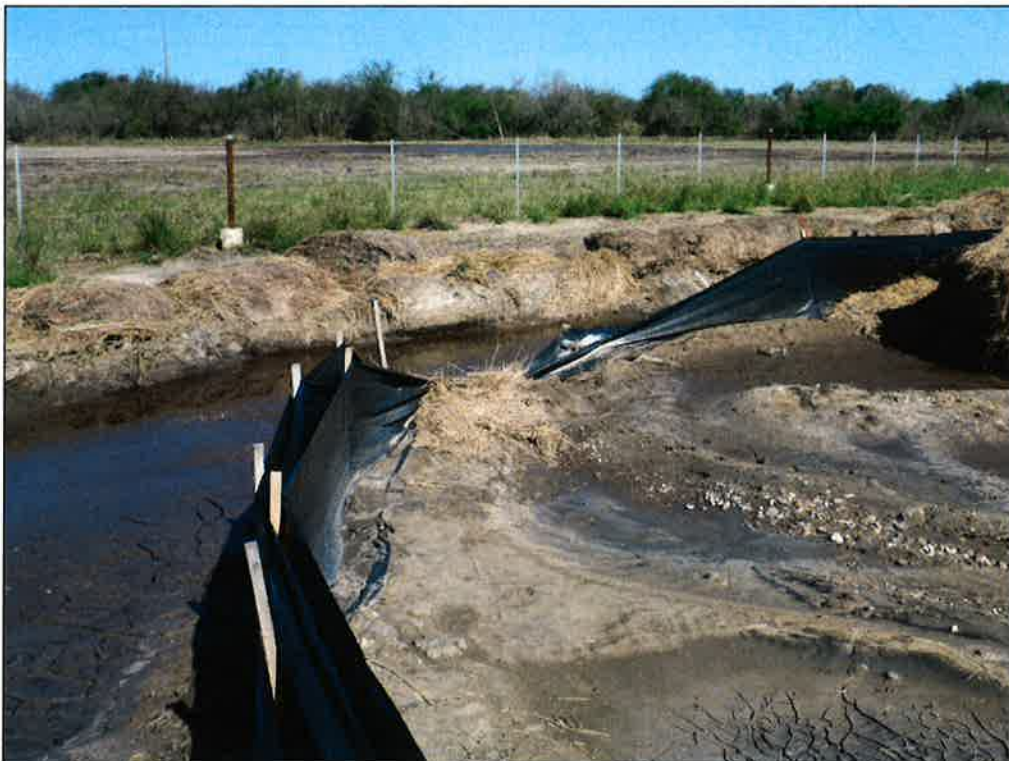
Photo 6. Overtopped silt fence (view north).

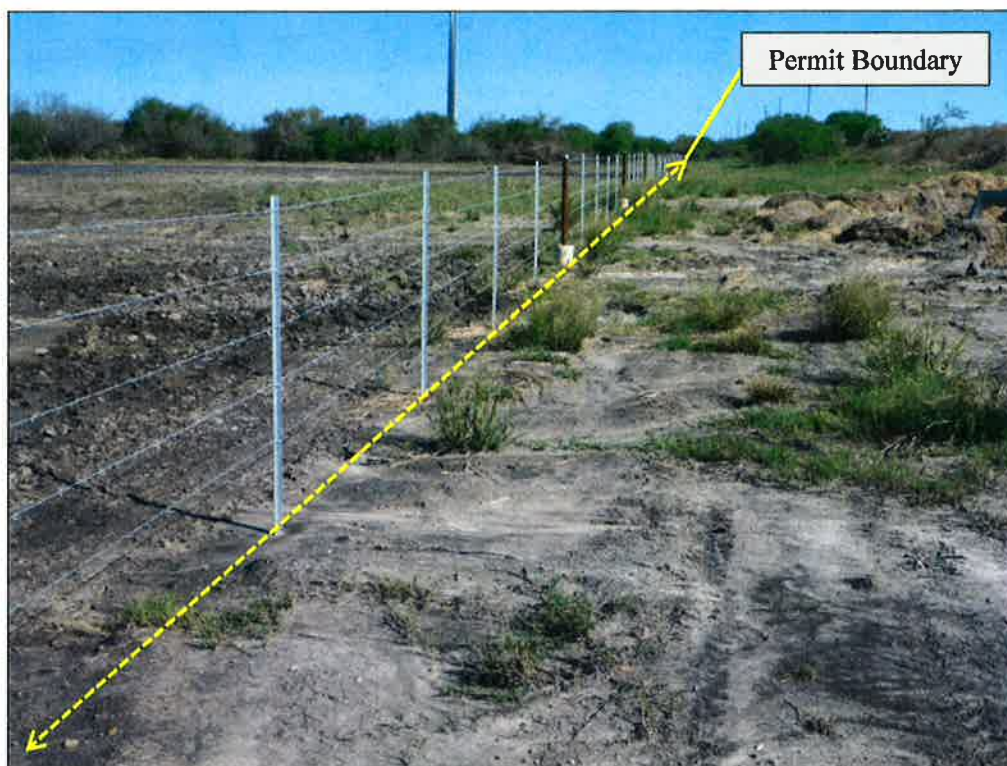
Photo 7. Lack of sediment control, sediment deposition offsite (view north).

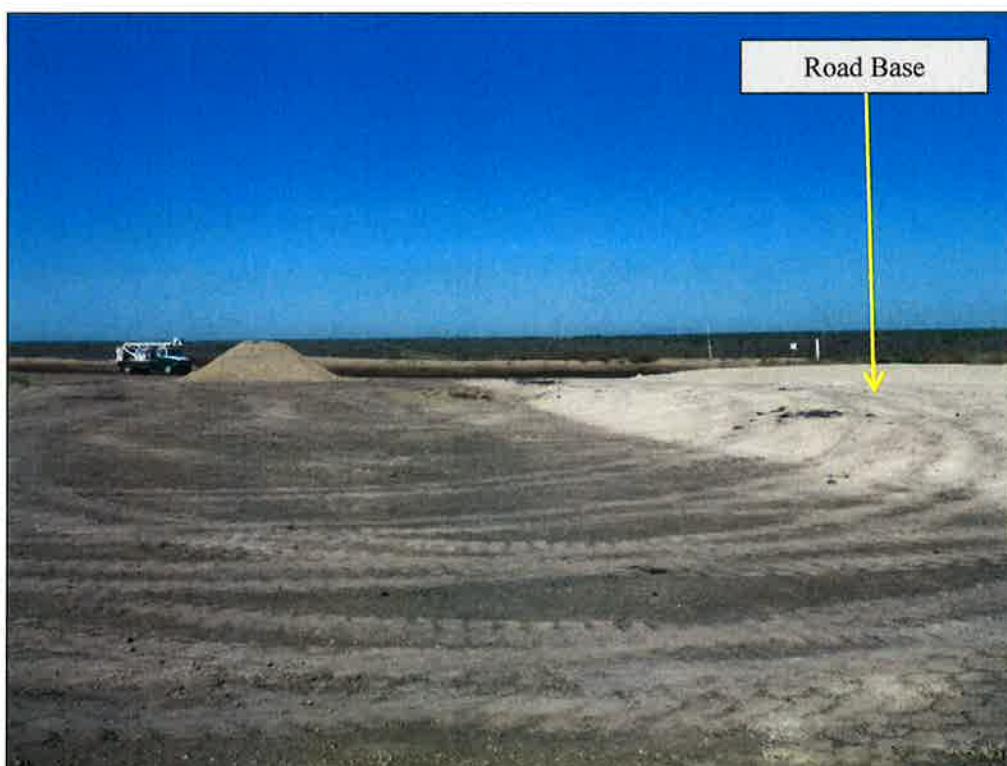
Photo 8. Road base material staged at the entrance to the Pond 10 Access Road (view west).

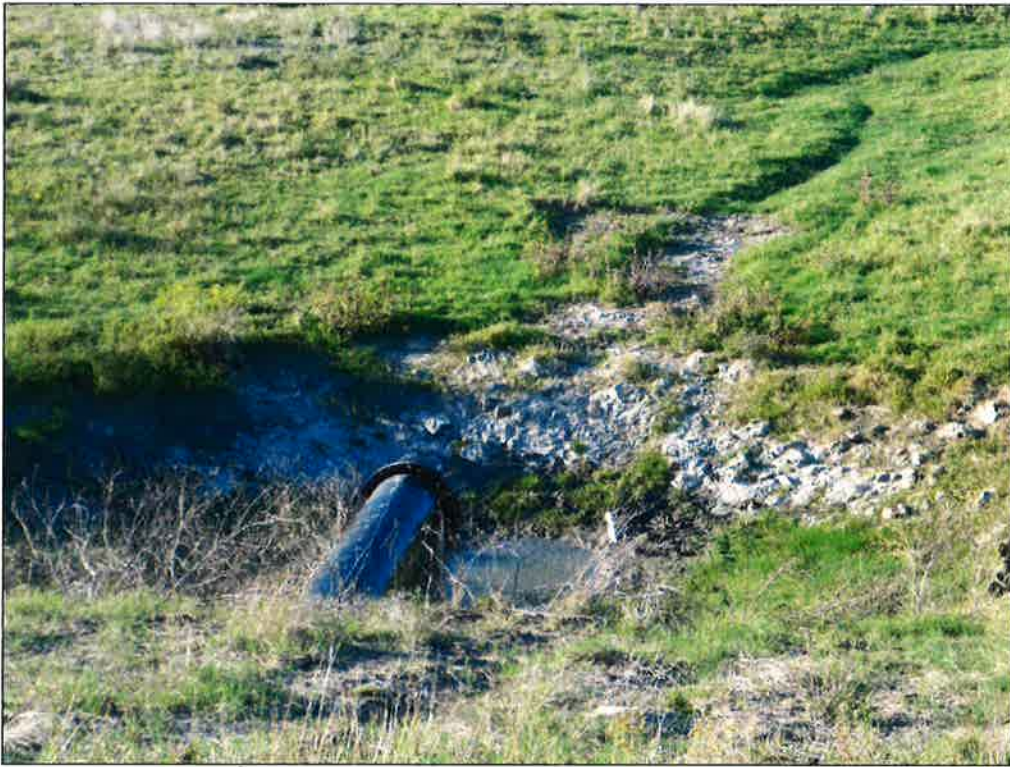
The ponds observed during the inspection appeared to be functioning as intended. No pond was observed discharging during the inspection. The Pond 15E discharge pipe (photo 9), Pond 1, Pond 8, and Pond A-1 were observed during the inspection (photos 10-12).

Photo 9. Pond 15E discharge pipe (view southwest).

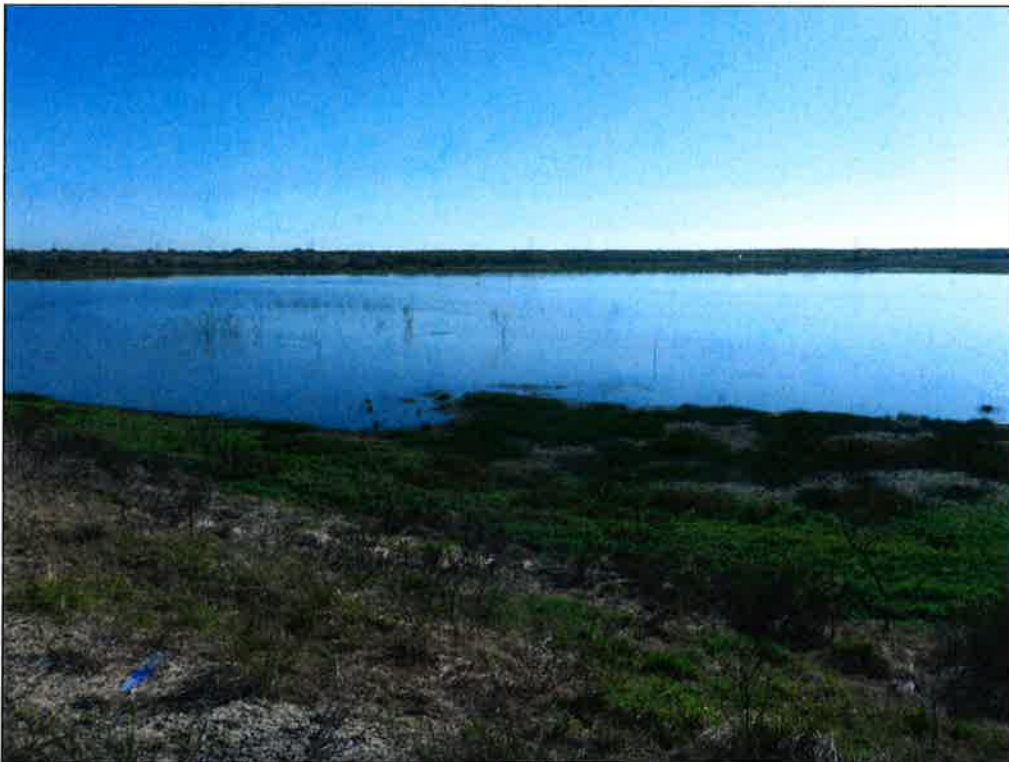
Photo 10. Pond 1 (view east).
